NDCRS ARCHITECTURAL FORM
PAGE 1

UPDATE

Map Quad Stanley Site Name Cottonwood School
Map Quad _____ Site Name Hauglie School

The school is located in Flickertail Village. Site updated to correct sketch map and add information.

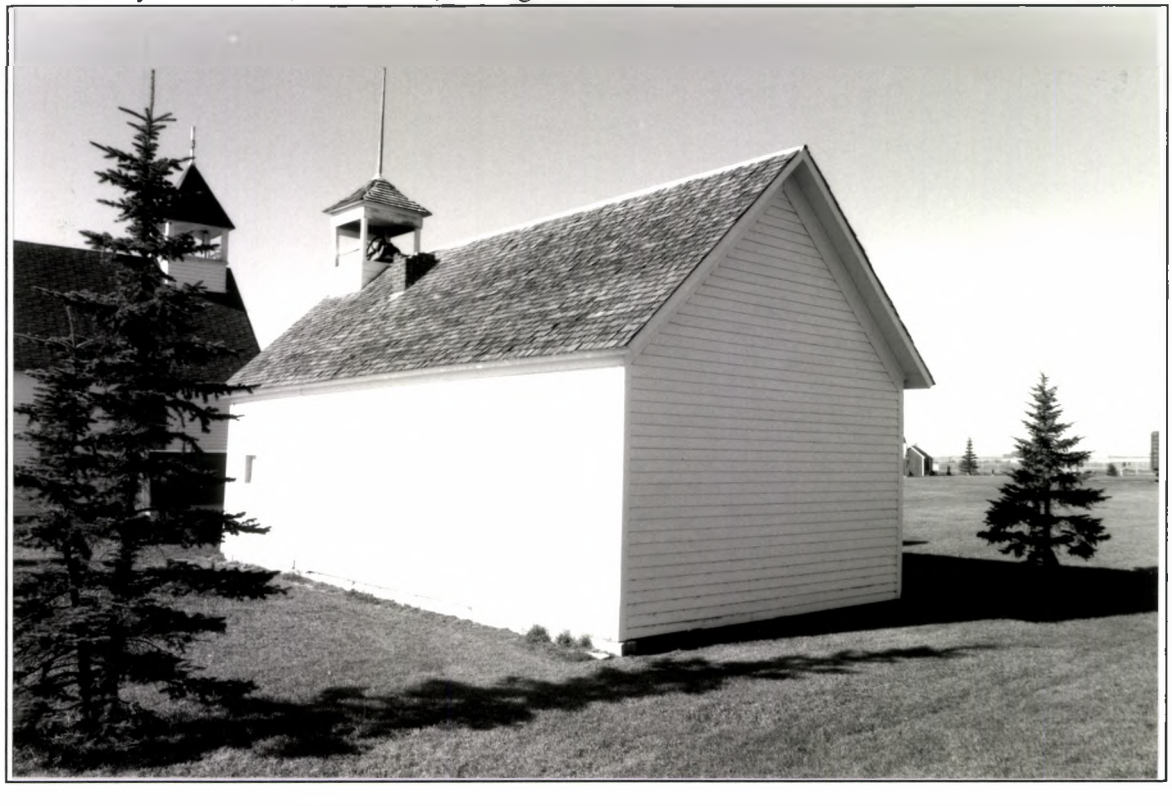
The building retains little integrity. Furthermore, its removal from its original location has damaged its eligibility. The building does not meet any of the considerations under Criteria Consideration B.

Front of Country School #3 (Feature #13), facing NE

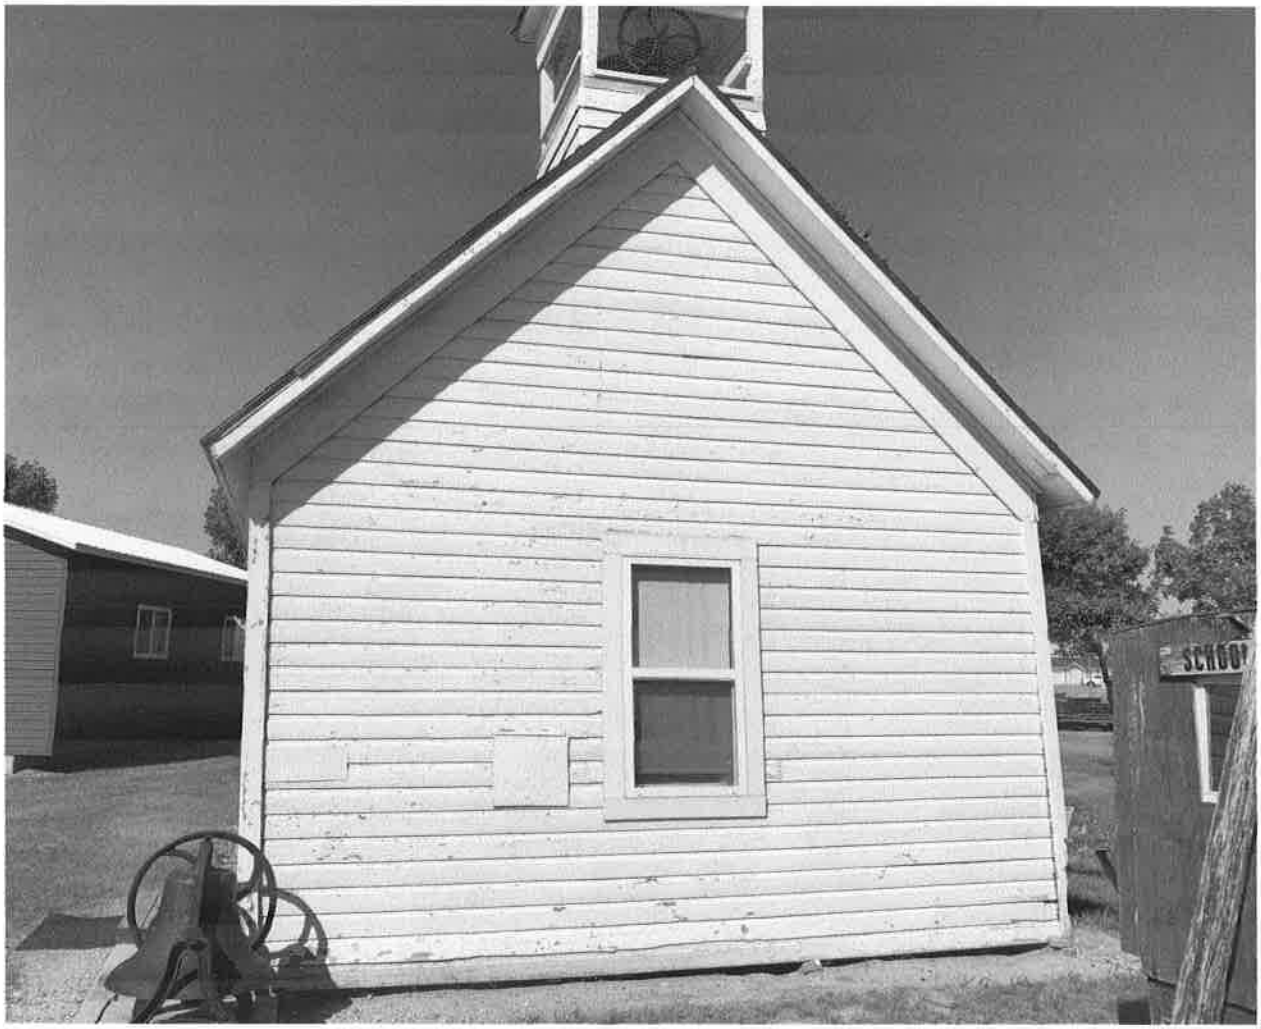
South-west Side
