NDCRS ARCHITECTURAL FORM
PAGE 1

Map Quad _____ Site Name Sheep Butte School
Map Quad _____ Site Name _____

1. County McKenzie 2. Site Number 32MZ445
3. Site Name (s) _____
4. Type of Resource: A. Archaeological__ Historical X Architectural__ Paleontological__
   B. District__ Site__ Building X Structure__ Object__

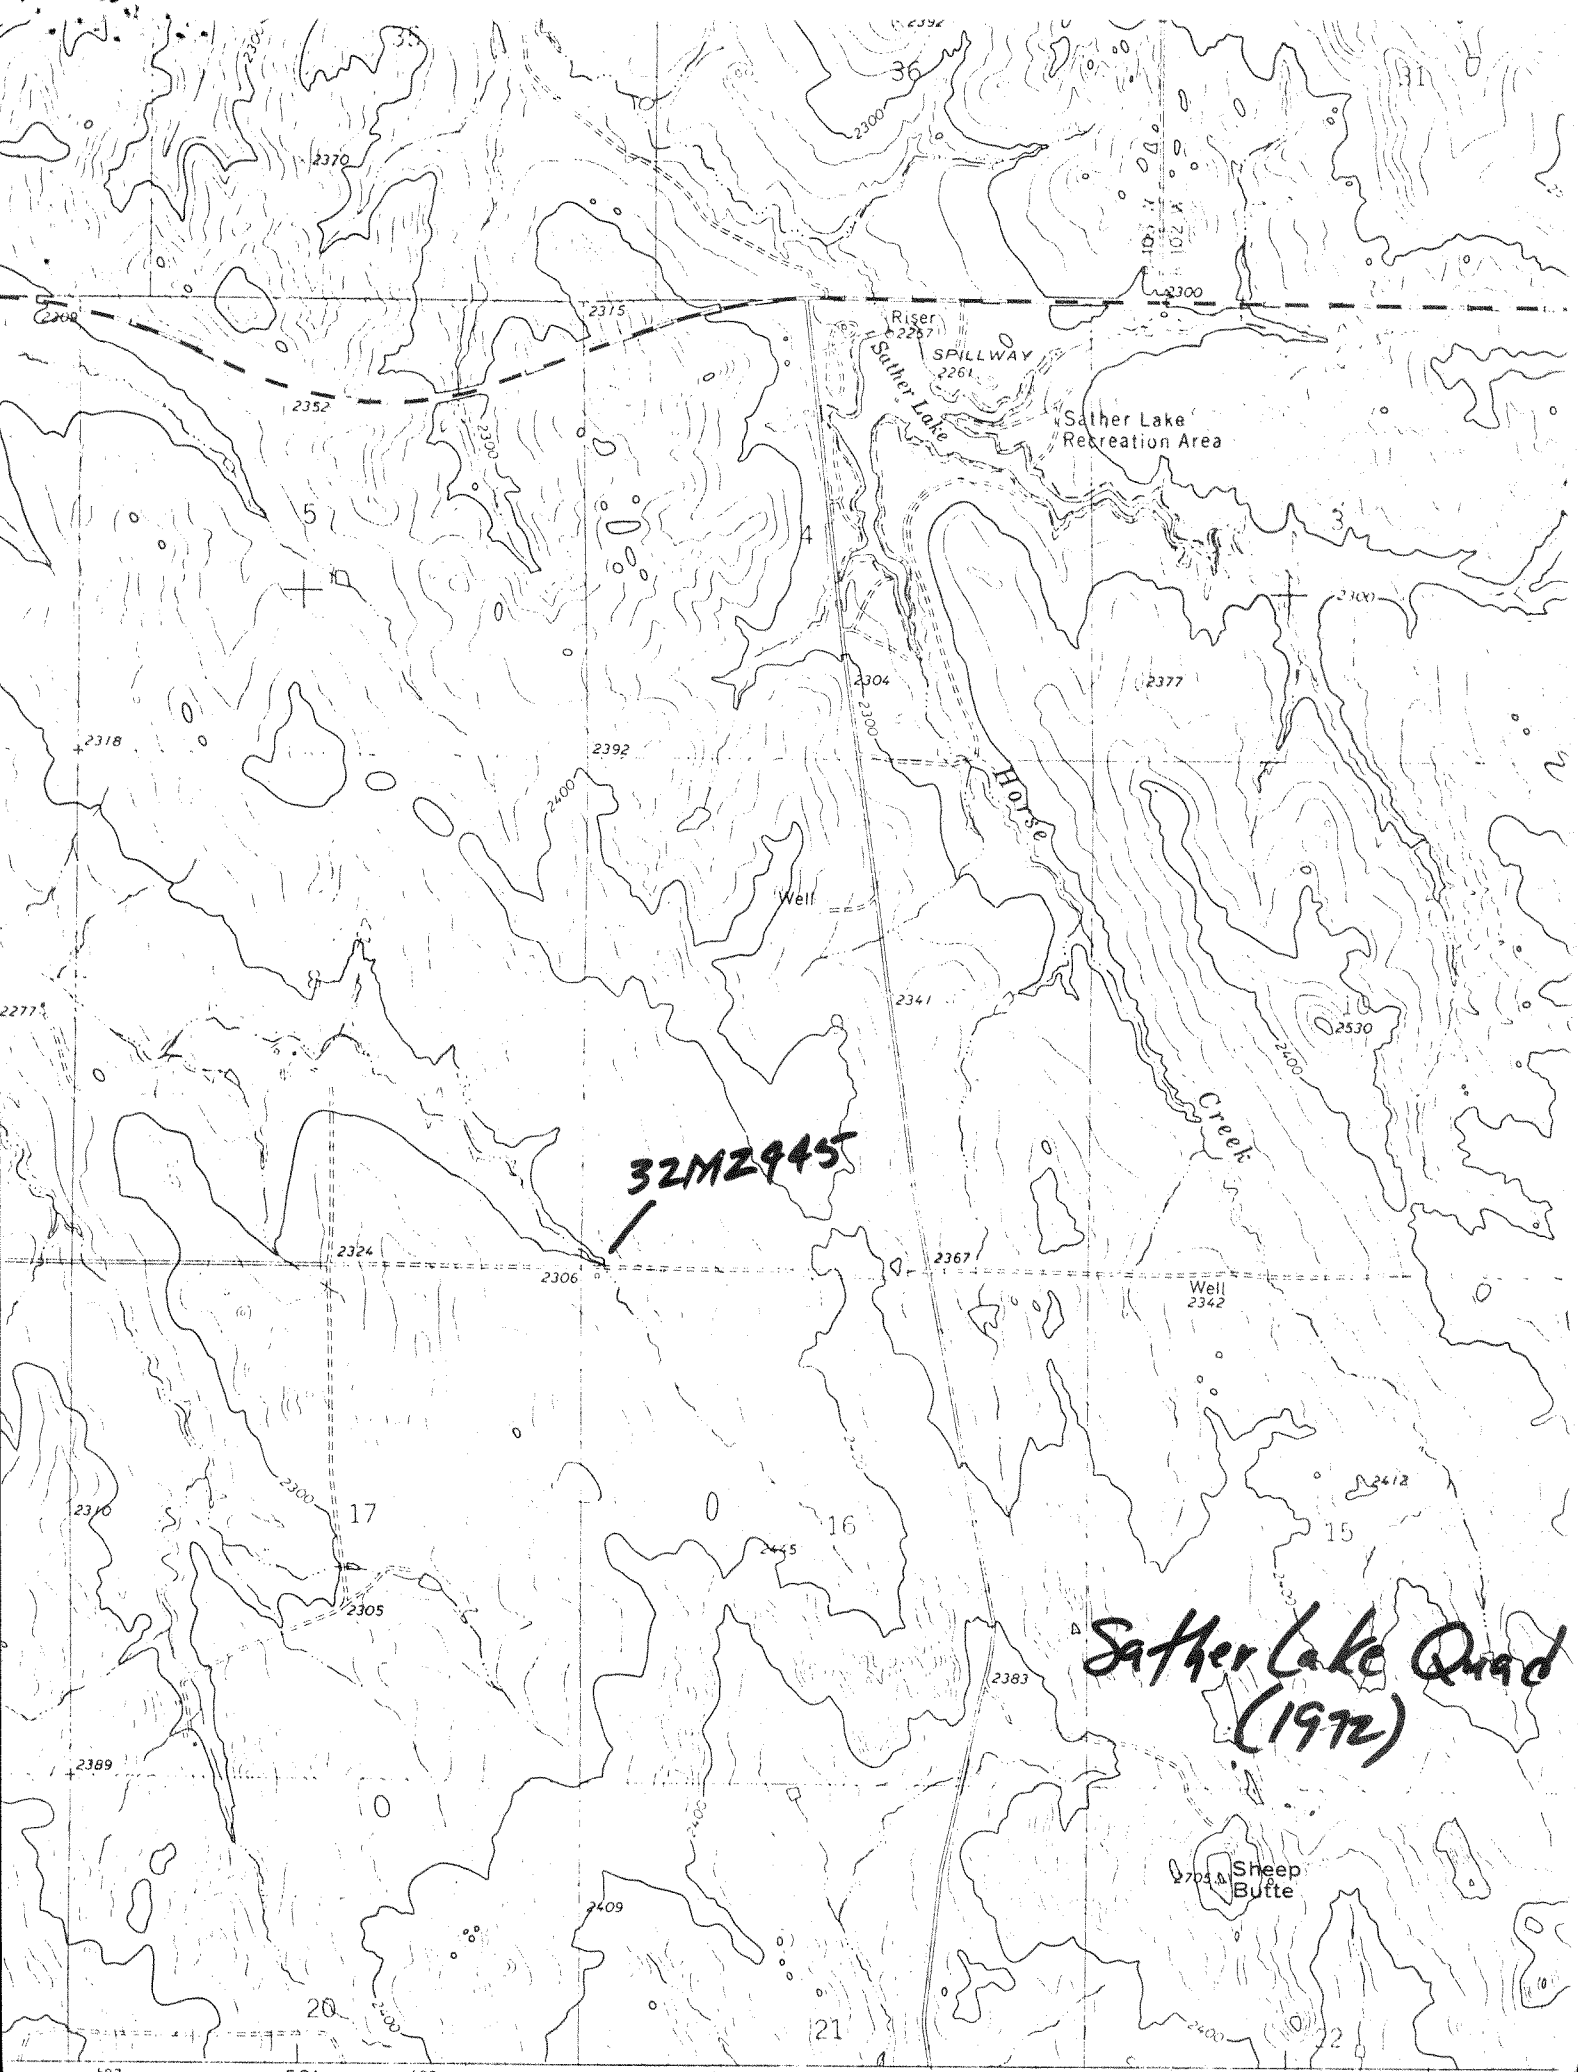
SITE NO. 32MZ445 LOCATION NW¼,NW¼,NW¼ SEC. 16 T. 148N R. 103W

Building is still standing and in good condition. Roof is peaked about 20 feet high. Building is 25' X 15' and sitting on a rock - mortar foundation.

North side has 5, 3' X 5' windows. South and east sides have no windows. Door and two side windows on west side. Door is 3' X 8' with two small 1½' X 1' windows over it. Door is gone - frame remains. Two windows are 2' X 2'.

Small cupboard in the southwest corner. Coat hooks along the west side.

Chimney and wood burning potbelly stove to the south of center near the east wall. Chimney center of east wall.

All construction frame - floor is frame. Ceiling gone - once at 10'. The bell tower is still on west side. Frame and tin square temple type top. Flat post still off the top.
